# The sustainable restoration of historic masonry: Robben Island

Loke, M.E., Kumar, P., Haldenwang, R.

## Abstract

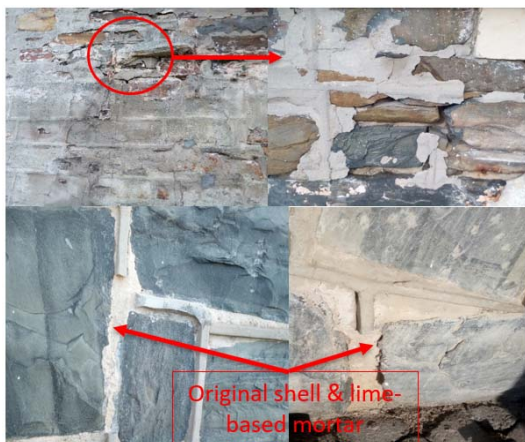
Some sections of the render, plaster and raised pointing were cement based. These take up a minority area of the buildings and were referred to as recently repaired areas. In most areas where such cement-based materials were used, the materials show signs of detaching from the original surfaces.

Figure 1. Recent repairs (Robben Island, 2019)

This calls for a compatible and sustainable approach that could only be achieved through original material characterization prior to restoration (Schueremans et al., 2011).
