## Reconnaissance survey of historic monumental unreinforced masonry building by visual inspection: A case study of senate hall building of Allahabad University, India

**ABSTRACT:** The Indo-Saracenic style of architecture reconnaissance survey is presented in the present work. The Senate Hall building is 106 years old unreinforced masonry of Allahabad University, India, built-in 1915. It was designed from Hindu (Stone Columns, Windows), Muslim (Domes, arches) architecture with British plans (inner rooms) like large halls, wide openings, porches, and facades. The building has been survived two major earthquakes, viz., Bihar Nepal (1934) and Nepal (2015). Masonry walls were constructed from cellular wall patterns ranging from 1.07m to 0.61m (thickness) from the ground floor to the first-floor level. Most buildings have observed major cracks and damages in masonry walls, connections, arches, and porches. The construction materials (binder and plaster) have continuously deteriorated due to environmental factors like atmospheric conditions, seepage, and moisture. This work is focused on developing a digital model of the SH building using visual inspection for future preservation.

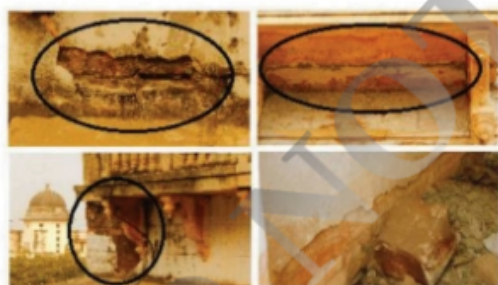
The current condition of the old unreinforced masonry SH building has been performed to assess its state viz., construction techniques, architecture style, structural materials, cracking patterns, material deterioration, damages and failures. Figure 2 shows the actual spalling of materials, damages, and failure of its components of the SH building. The geometrical plan and elevation drawing is prepared during the building's continuous survey. The cracks, deterioration and damages of the building are noted and marked.

Figure 2. Major cracks and material deterioration of SH building.

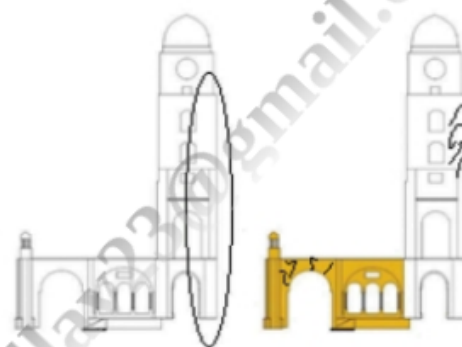
*hall (ME)*, *Examination Hall (EH)* and *central hall (CH)*. The geometrical dimensions of the ME and EH are the same, and they are situated on both sides of CH. CH is large among all three halls. The CH is spacious with twelve doors, and sixteen windows are situated at North, South, East, and West masonry walls on the ground floor level. It is used for meetings, examination, convocation, conferences, social and cultural activities. The brick masonry is coloured yellow, and the stone materials are red. In visual inspection, major cracks and damages have been observed on the entire building. The decorating and plaster material has deteriorated on masonry walls, stone arches, roofs. The major cracks have visible on the connections and crown of the arches. The masonry wall is overturned through the ground floor to the second floor of the south entrance porch gate shown in Figure 3.

Figure 3. Minor cracks visible in clock tower and arches of front porch.

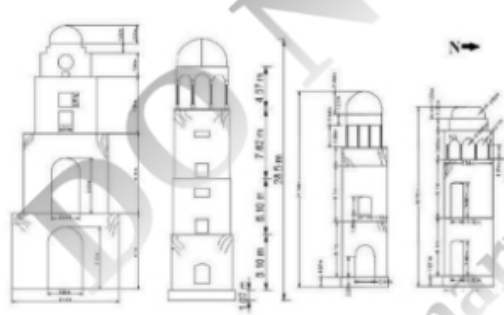
Figure 7. Minor cracks visible in stone material of towers element.

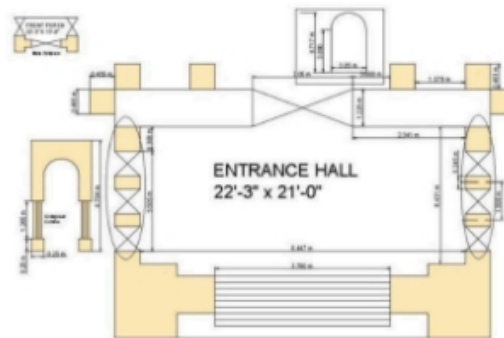
**Stone shades:** The connection between stones has been corroded due to rainwater seepage and algae formation on the shades. During the survey, many replacements work is required to protect. The shades have mainly been provided in balcony and towers element through each floor level. The major cracks and material deterioration has been visible in decorating elements (towers, arches and porches) of the building shown in Figure 7 and Figure 8. Most portions have been renovated from new materials through the ground floor to the second floor.

Figure 8. Cracks and material deteriorated in east entrance stone porch of the building.
