# Study of the construction techniques, materials and architectural prospectives of ancient monumental structures in Allahabad City, India

**Abstract.** This research examines the construction methodologies, materials, and architectural principles employed in creating ancient monumental structures in Allahabad (now Prayagraj), India. Despite being erected over 600 years ago, these structures stand resiliently among the evolution of modern construction techniques and seismic safety standards. The history of Prayagraj can be traced back to ancient times. The city was initially referenced in the ancient Hindu scriptures, known as the Vedas, as a sacred destination. Further, established by the Mughal Empire under Akbar's reign in 1583, Allahabad City witnessed the construction of numerous monumental structures using robust techniques involving stone, brick masonry, and timber materials bonded together with thin mortar and plaster. Many of these ancient edifices, erected during this period, continue to serve various functions today, reflecting the enduring craftsmanship of their builders. In this study, we have identified prestigious monuments for examination, utilizing visual inspecti

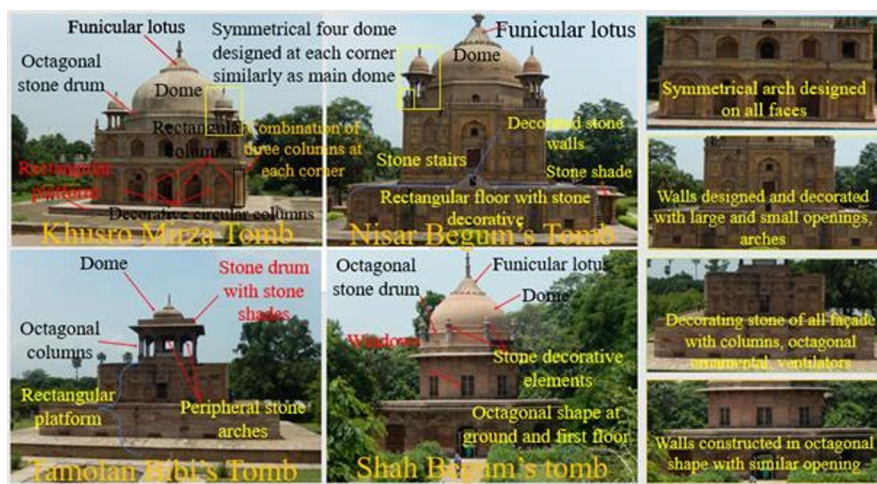
Fig. 2. Structural view of Khusro Bagh tombs

For instance, the Khusro Bagh tomb predominantly features a single-domed structure with four fluted shoulder stone domes resting on octagonal stone drums shown in Fig. 2. The central dome of Khusro tomb is the bigger dome, larger than the side ones, covering the mosque, with four mihrabs inside the stone wall corresponding to the one entrance. The rectangular plans with octagonal corner minarets are evident in transition phases, such as in the Allahabad Fort mosque, which also features a corner tower with flanking turrets. Its rows of recessed niches and cusped arches give it a sophisticated appearance that sets it apart from modern buildings.

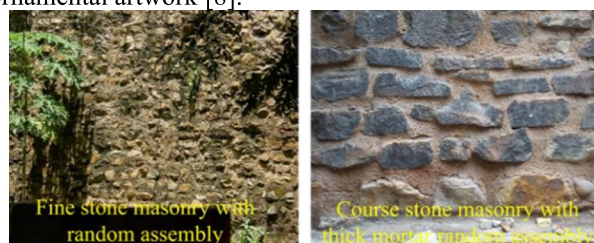
**Fig. 3.** Thick layer of lime mortar on the outer wall of Khusro Bagh

Field visits to specific places reveal the exact extent of the damages and the current state of the monuments. The strength of both decorative and structural cladding materials has been considerably reduced. These constructions serve as a showcase for the many local and imported materials used during the period. The typical Mughal brick measures 8 inches  $\times$  4 inches  $\times$  1 3/4 inches, and it has a coating of lime mortar that is nearly one inch thick. Rich

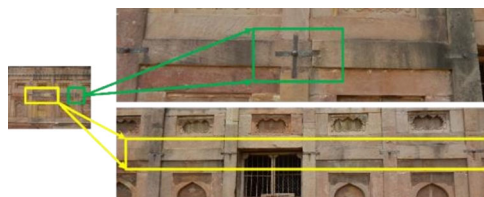
**Fig. 7** Connection element used in Mughal tombs

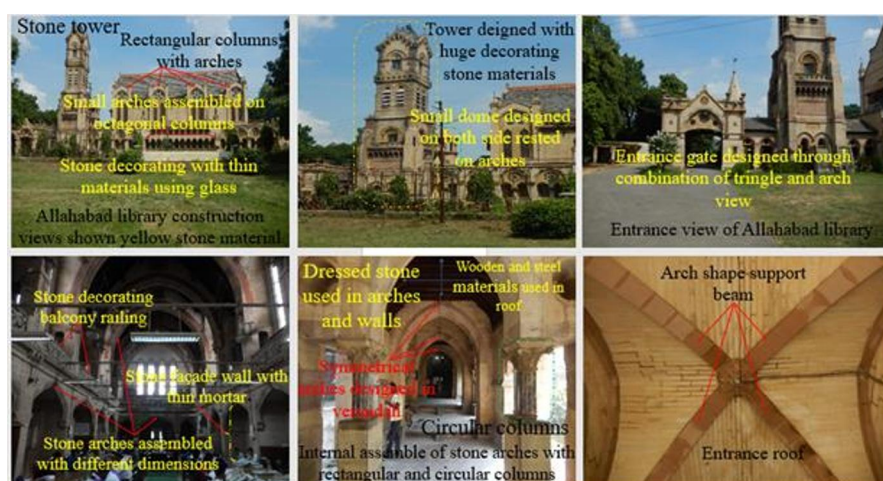
Fig. 8 shows the location of the Allahabad Public Library (1864), also called the Thornhill Mayne Memorial, in Chandrashekhar Azad Park. This library, created by Richard Roskell Bayne, is a prime example of Scottish Baronial Revival building design. It is among Uttar Pradesh's largest libraries in terms of size. The building's architecture, with its tall towers and arcaded cloisters, showcases structural polychromy with its pointed granite and sandstone pillars and turrets. The entrance gate is especially noteworthy since it combines triangular stones with arch connections to the building's architectural grandeur. A high stone tower has been constructed on the right side of the main gate. Most decorated stone materials are designed from the ground floor to the top. The rectangular shape is visible on the ground floor and first floor, and many openings are designed with lofty shapes. The main building has been designed with huge columns and arches. Rectangular and circular columns are provided in main load-bearing elements, and walls are assembled with stone materials. All structural elements of the building are constructed from the stone materials. The main roof has been designed triangularly, supported by wood and iron elements.

**Fig. 8** Architectural views of Allahabad Public Library

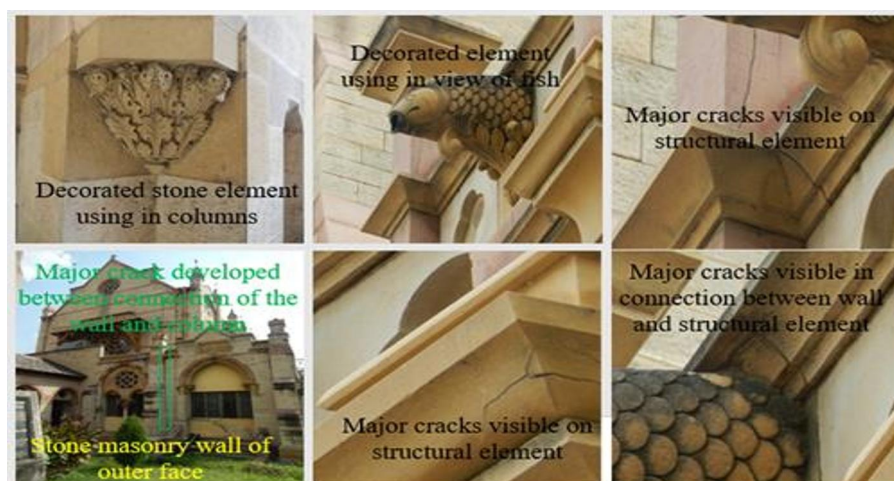
**Fig. 9** Decorative element use in Allahabad Public Library

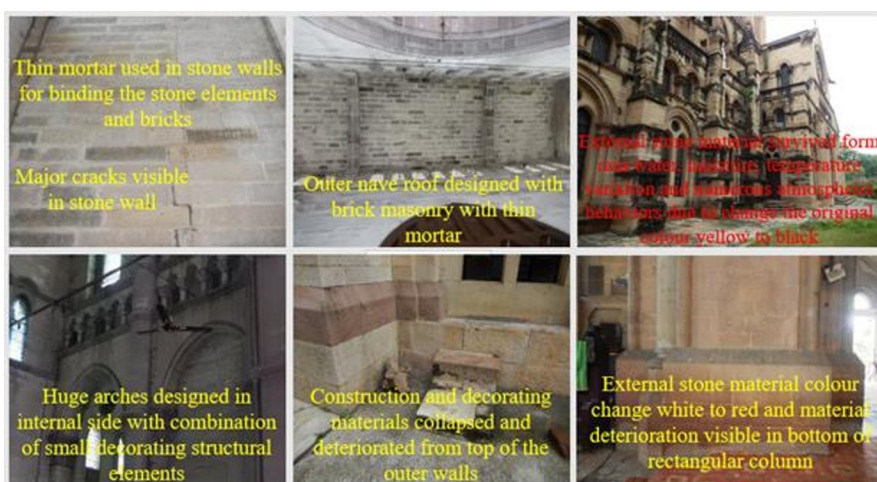
**Fig. 11** Cracks and material deterioration of All saint cathedral church

The complete framework is assembled during the visual examination, utilizing load-bearing structural components. Large pillars and surrounding arches were created on both the interior and exterior of the Cathedral. Arches are used in a combination for construction on either side of the outer nave. Internal side arches run continuously from bottom to top, while outer side arches vary in size. The peripheral walls and columns on the outer arches are intended to form a broad verandah on the ground floor, first floor, and second floor. The Nave roof is made of a small portion of stone masonry and a thin layer of mortar. Mortar has been precisely employed in this structure for binding and ornamenting the walls, arches, columns, etc., as depicted in Fig. 11. The large and small fissures can be seen in the stone walls on the inside. Small and insignificant cracks have been noticed on all buildings' stone columns, arches, and façade walls. The external colour has lost its brightness because of weather conditions, showing a dark hue on everything from the building to the decorations. Building and design materials have consistently degraded and warped structural and decorative parts. Significant ornamental features have fallen on the structure's roof, as depicted in Figure 11.

This research suggests thoroughly inspecting all monuments to detect and fix any cracks, damages, or structural issues by utilizing contemporary materials and methods. Maintaining these historic buildings is essential for comprehending previous architectural designs and techniques. Following correct restoration methods is essential to guarantee these historical landmarks' extended lifespan and ongoing admiration.
