# Analysis of Century Old Masonry Tower of Indo-Sarascenic style: Visual Inspection, NDT and FEM

Ambareesh Kumar<sup>1</sup> · Kumar Pallav<sup>2</sup>

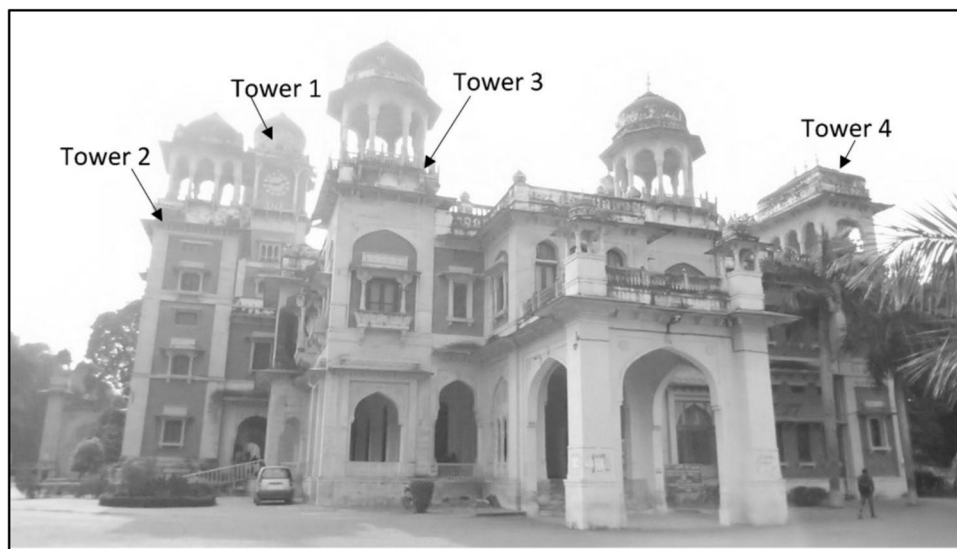
**Fig. 1** Structural view of the unreinforced masonry Senate Hall building with towers

Built in 1915 during the British era, the building, depicted in Fig. 1, features a load-bearing brick masonry structure. Stones were used for support and ornamentation, including plinths, openings, arches, columns, and balconies. Towers, essential structural components, come in diverse cross-sections and heights. These towers throughout the building employ distinct construction methods and geometrical specifications. The SH building is a remarkable example of a load-bearing structure featuring unreinforced brick masonry

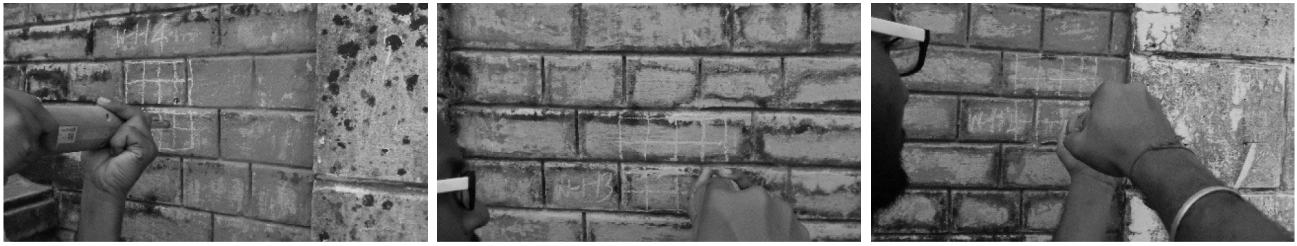
**Fig. 8** RH testing on WoP masonry walls of tower elements with relationship b/w RH index and compressive strength

RH testing was conducted on the unplastered ("WoP") brick masonry walls of the tower elements at the first and second-floor levels. These tests were performed on the external sides of the tower elements, presenting challenges in selecting appropriate testing locations. The outer surfaces of these tower elements are directly exposed to weather and atmospheric conditions, including temperature variations, rainwater, seepage, and moisture, all of which contribute to the deterioration of brick materials and the formation of cracks. These factors also affect the colour of the masonry.

(a) Identified locations of WoP masonry walls

(b) Correlation between RH index and compressive strength
