# Physical characterization of heritage mortars for restoration interventions

**Abstract**—The analysis of old mortars is performed for either conservation, repair or the compatible restoration of heritage buildings. It includes experimental analysis of original materials from historic buildings using the non-destructive methods. The methods such as visual investigation, color test, cohesion test and microscopic analysis are considered the most cost-effective methods for determining the composition of heritage mortars. The paper reports the results of an experimental investigation into the physical properties of the cementing materials from the oldest colonial building in South Africa; *Castle of Good Hope*. The original materials from the Castle were made of lime as a binder, fragments of seashells as aggregates and soil mortars without a binder. The physical characterization of original heritage mortars gives details of the binder type and the aggregate type. It may help to achieve the sustainable restoration of ancient buildings.

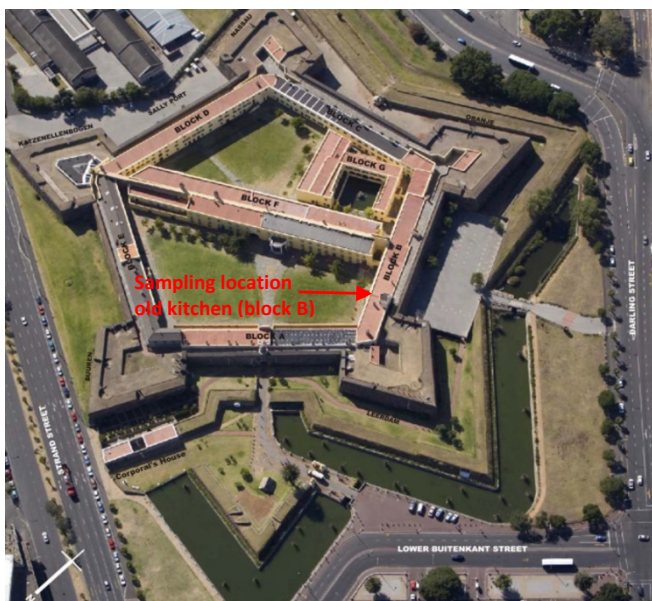
Figure 3. Castle of Good Hope, South Africa [13]

The Castle is the second fort at the Cape which dates back from 1666 to 1679. It is considered the oldest existing colonial building in South Africa [15]. This historic building has a pentagon shape and is made of stone and block masonry, as shown in Fig. 3. At present, the Castle houses the administration and organization elements of the military (Headquarters of Western Cape Command). The structure is open for tourists.

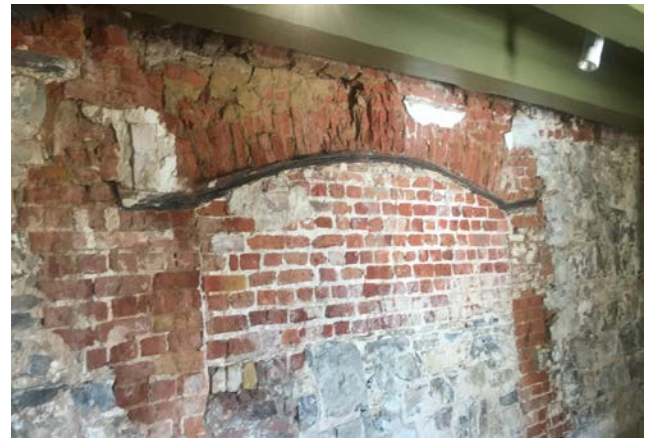
Figure 4. Internal masonry, Castle of Good Hope-South Africa

The samples were collected from Block B - old kitchen and taken to the laboratory for analysis. Prior to laboratory testing, a thorough on-site visual investigation was carried out. The analysis was investigating the aspects of mortar used, such as the degree of deterioration and the condition of the surface material (original or repairs). Fig. 4 indicates the location where the samples were collected.

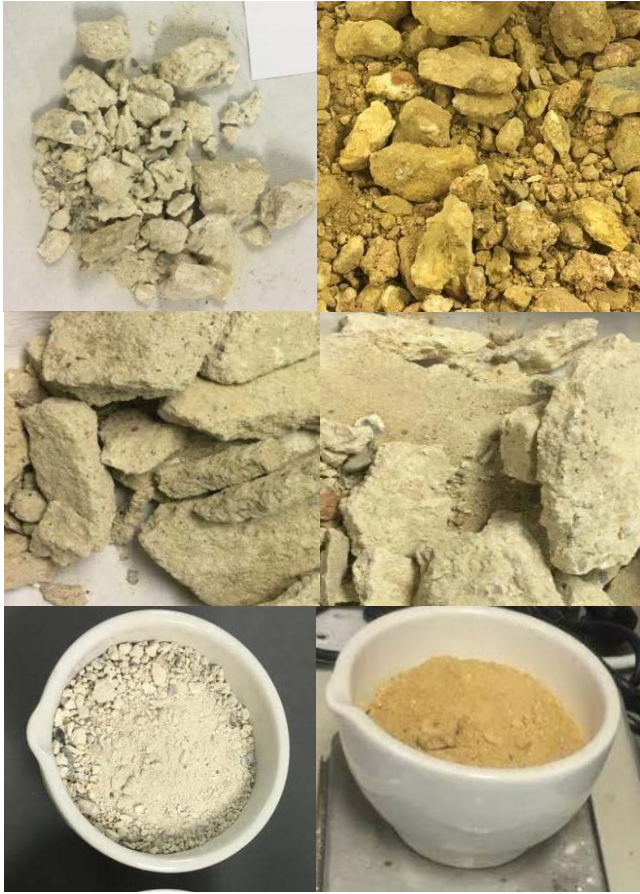
Figure 5. Test samples

A total of nine representative samples were collected for analysis using a small hammer and a chisel. Where possible, 1 kg of materials were collected from the floor, plaster and the bedding materials. Areas targeted were those who were already damaged, to avoid causing disturbance to the structure. All the samples were named and described according to their appearance in terms of color, texture and location in accordance with the sampling data sheet [17]. The data sheet shows information such as the sample location (wall, foundation, exterior or interior), the function of the sample being either render, plaster or jointing/bedding among the essential details. Fig. 5 shows some of the samples during collection before they were physically analysed and the prepared materials awaiting analysis.

After collection of the intact materials as indicated above, the samples were prepared for further analysis through gentle crushing using a mortar and pestle. It was done to avoid breaking the respective particle sizes of aggregates that would have an impact on the gradation curve.

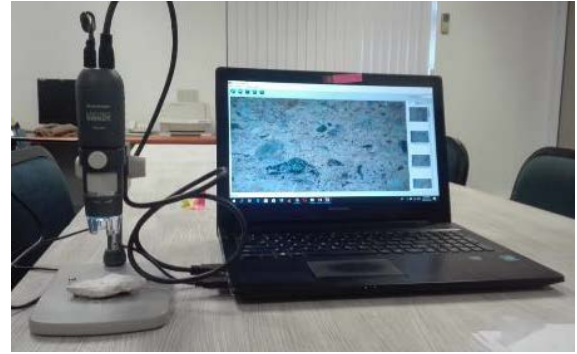
Figure 6. Microscopic analysis set-up

- **Microscopic analysis:** The mortar chip is placed under an optical microscope (see Fig. 6) to evaluate the particle distribution and the particle sizes. From

this characterization method, the size of the particles of additives is determined to lead the restorer in search of replica repair materials. The microscopic images display magnified details of the sample that were missed by the naked eye. A procedure by [18] was referenced in this study.
