# Old masonry tower analysis visual inspection, NDT, and macro-modeling

**Keywords** Old structures · Visual inspection · Unreinforced masonry · Cracks and damages · Finite element modeling · Static analysis

The study focused on the tower element, the third-highest tower of the Senate Hall building in Allahabad University,

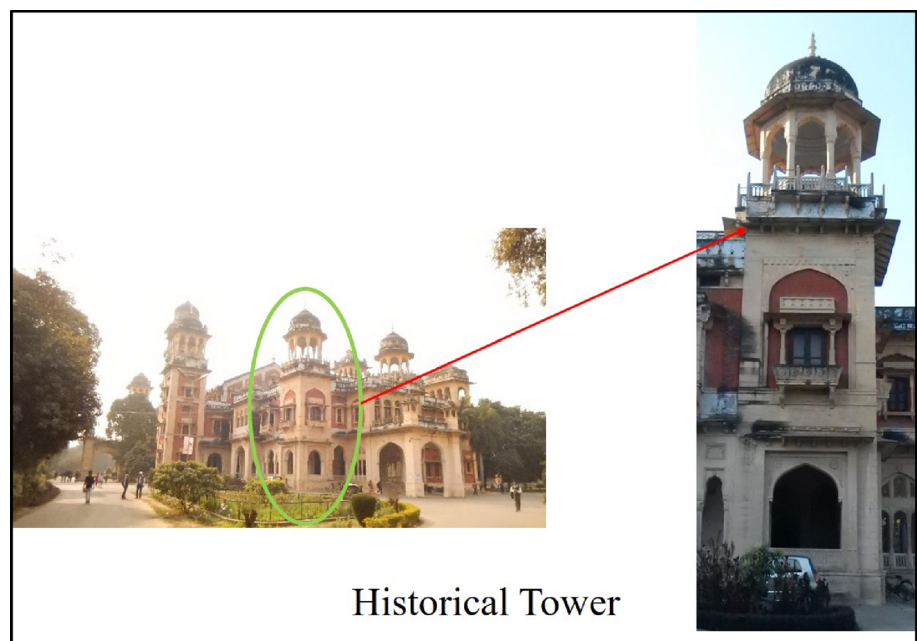
**Fig. 1** Structural view of the tower

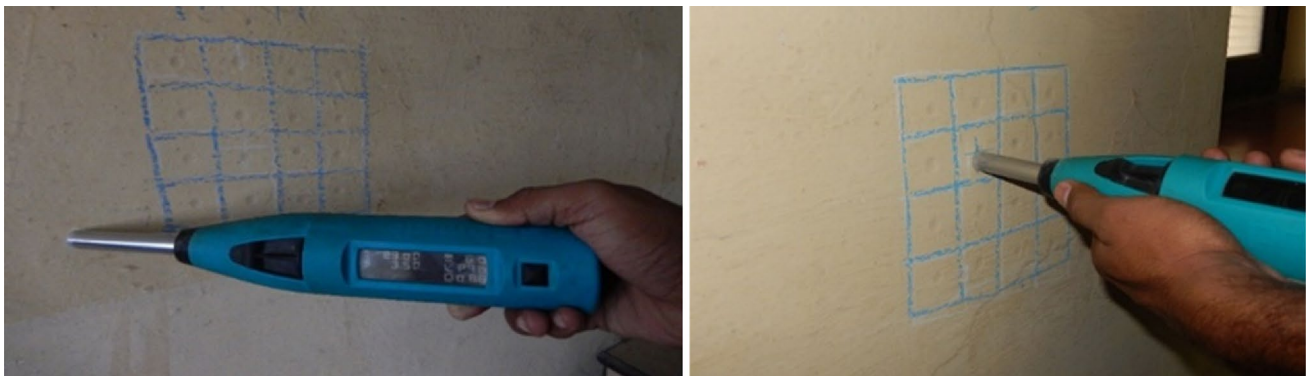
Figure 4 displays the Schmidt rebound hammer and the testing locations. The versatile hammer weighs approximately 1.8 kg, making it appropriate for use in laboratory and field settings. The hammer comprises four primary components: the outer body, the plunger, the hammer mass, and the main spring. Pressing the hammer firmly against the

surface allows the body to move away from it until the latch connects the hammer mass to the plunger. This movement extends the spring that holds the mass to the body. The hammer can be used in various positions, including horizontally, vertically overhead, vertically downward, or any angle in between, as long as it is perpendicular to the tested surface. However, the mass's position relative to the vertical impacts the rebound number due to the influence of gravity on the hammer's mass.

**Fig. 4** Schematic view of the Schmidt Rebound Hammer
